## A NEW LEASE ON Light

Take a peek behind the (busy) scenes of the Museum of Art's epic centennial renovation.

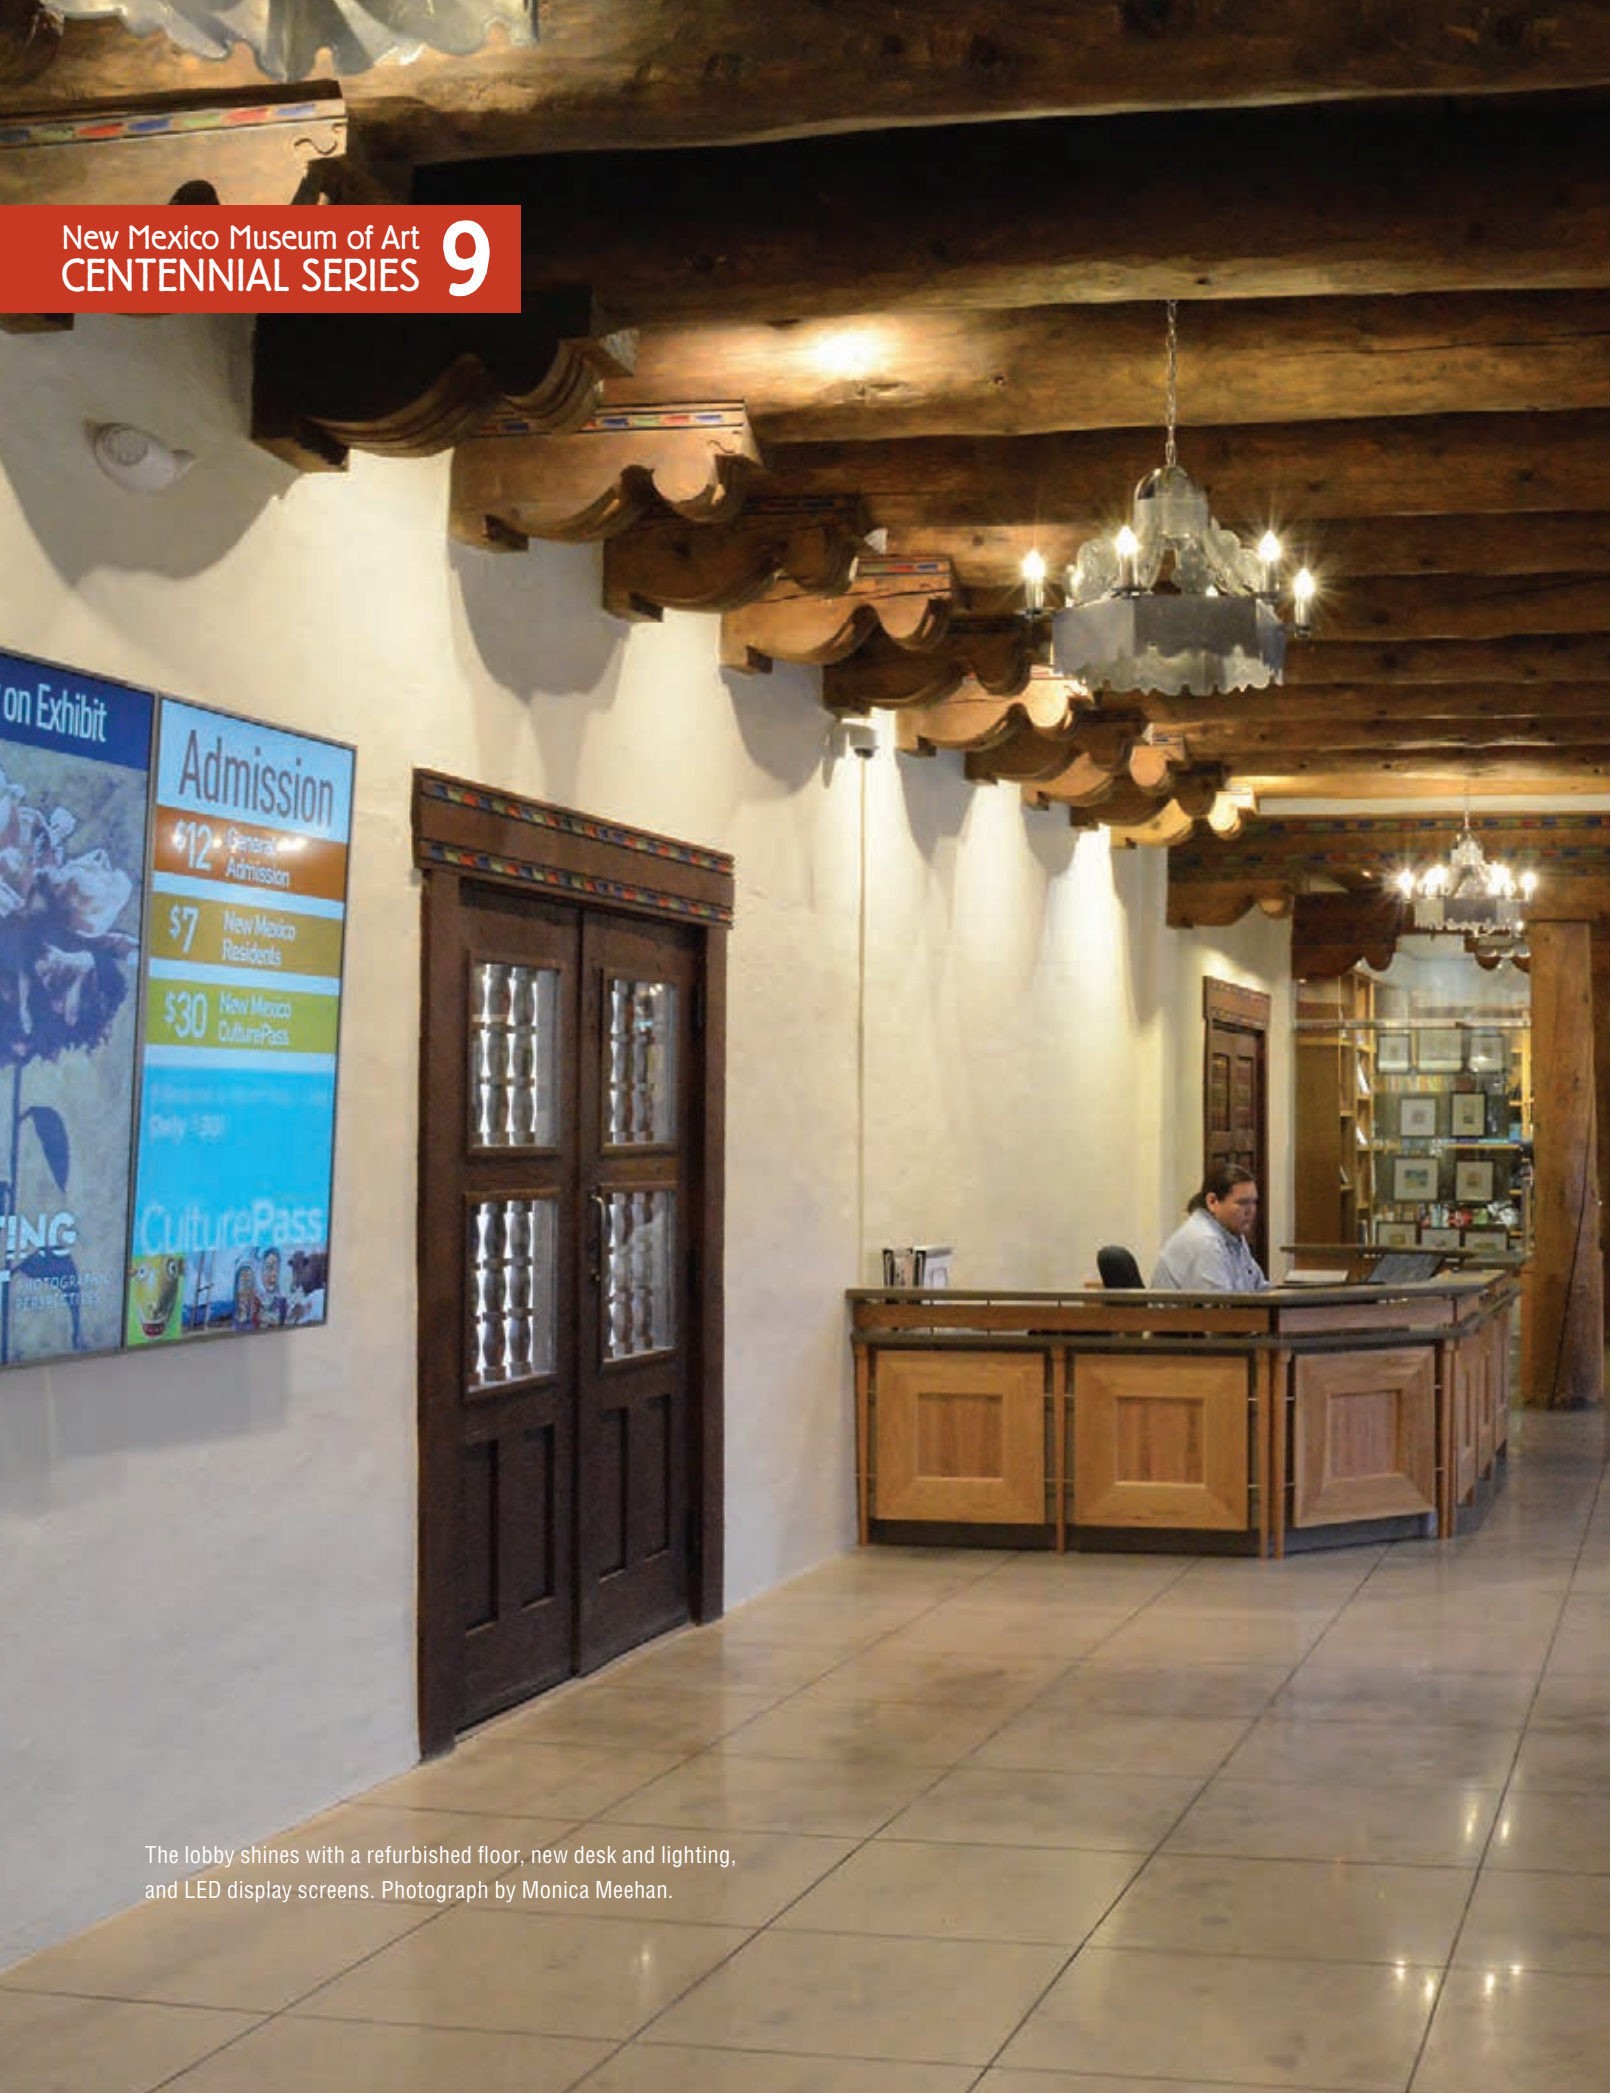
The lobby shines with a refurbished floor, new desk and lighting, and LED display screens. Photograph by Monica Meehan.

We also worked with talented craftspeople when updating the museum's versatile lobby, where we greet museum visitors, host receptions, and receive people who are on their way to events in St. Francis Auditorium. In addition to the dramatically lighter floor, we installed new recessed LED lights that mimic the undulations of the latillas, and help to increase the overall illumination of the space. The recessed lights replaced mismatched track lighting added over the years, reducing visual clutter near the ceiling. As a result, many longtime visitors now comment on the carvings on the corbel ends, having never noticed them before.

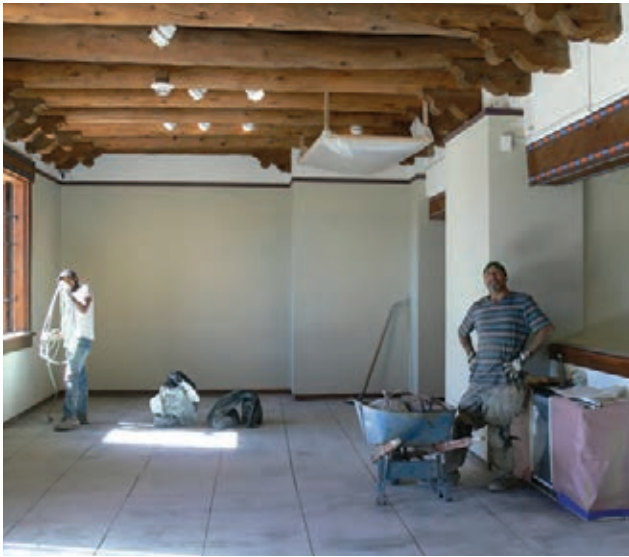
Workers from Advanced Concrete Design in the Beauregard Gallery, after they removed the initial layer from the floors with a terrazzo grinder. Photograph by Michelle Gallagher Roberts.

The most complex and least predictable part of the planned renovations was the restoration of the floors throughout the building. When the museum first opened its doors in 1917, the hand-poured concrete floors were a light color which helped to reflect light up onto the walls and ceiling. A detailed examination of the concrete throughout the museum showed a mix of challenges. After 100 years of use and various treatments, the floors had become dark, discolored, and uneven. While the floors had some remedial treatment in the 1980s, by 2017, the floors were again in acute need of attention. In various areas, the surface of the concrete was spalling (partially deteriorating and separating).

Mexico Conservation Bureau and the New Mexico Historic Preservation Division, we identified the best solution to achieve our goals with the least amount of risk: grinding, polishing, and sealing 13,200 square feet of floors, plus 420 square feet of stair treads and risers. It was clear from the start that every section of the floor would offer a unique challenge, as the concrete mixes in different areas had various colors and textures. We wouldn't know exactly what we would be facing until the discolored surface treatments were removed.

Advanced Concrete Design, the floor subcontractor, completed the first stage with a terrazzo grinder, which uses different grades of stones (from coarse to polishing) to achieve a glossy finish. ACD workers also hand-cleaned about 15,000 linear feet of joints. The grinding and polishing process removed approximately  $\frac{1}{32}$  inch of floor surface, and in some areas, exposed the sand and stone aggregate below. ACD applied a water-based densifier to the surface in order to solidify and strengthen it. They consolidated voids and areas of spalling with a color-matched concrete epoxy, and applied a final two coats of a clear low-sheen sealer throughout the museum.

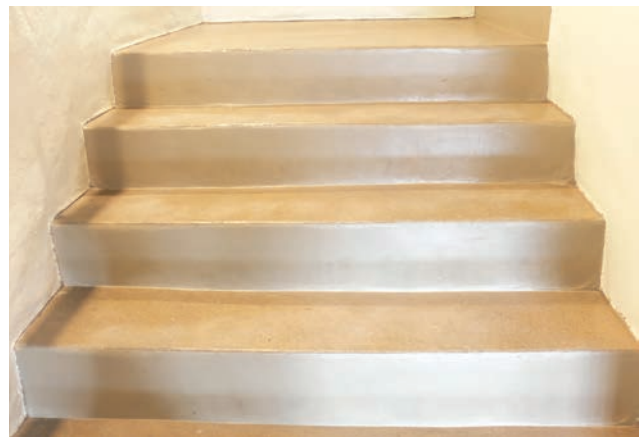
The staircase leading up to the second floor, post-renovation. Photograph by Michelle Gallagher Roberts.

The two staircases in the museum had the potential to derail the renovation schedule. The large terrazzo grinders couldn't be used on the stairs, so workers had to use small, hand-held grinders. At some point in the past, someone had covered and then painted the surface of the stair risers. We knew the plaster was hiding something; we just didn't know what. Since the plaster had started to crack and chip off in large sections, leaving it alone wasn't an option.

After the grinders removed the paint and plaster, we finally saw what had been hiding. It appeared as though an additional two inches of concrete had been added at some point in order to make the stairs taller. The point at which the two pieces of concrete met, which was clearly visible on the stair riser, had a very noticeable crack, with significant voids. Some stairs had bigger cavities than others. The general contractor and the New Mexico Historic Preservation Division staff hypothesized that perhaps when the stairs were first poured, they were too short to reach the second floor, and an additional two inches of concrete was added. Over the years, the seam had cracked and separated. To solve this problem, workers filled the voids and cracks with a bonding agent, and painted the risers with a neutral matching color. We chose not to paint the stair treads, letting their natural concrete color shine through a clear sealer mixed with grit to provide traction.

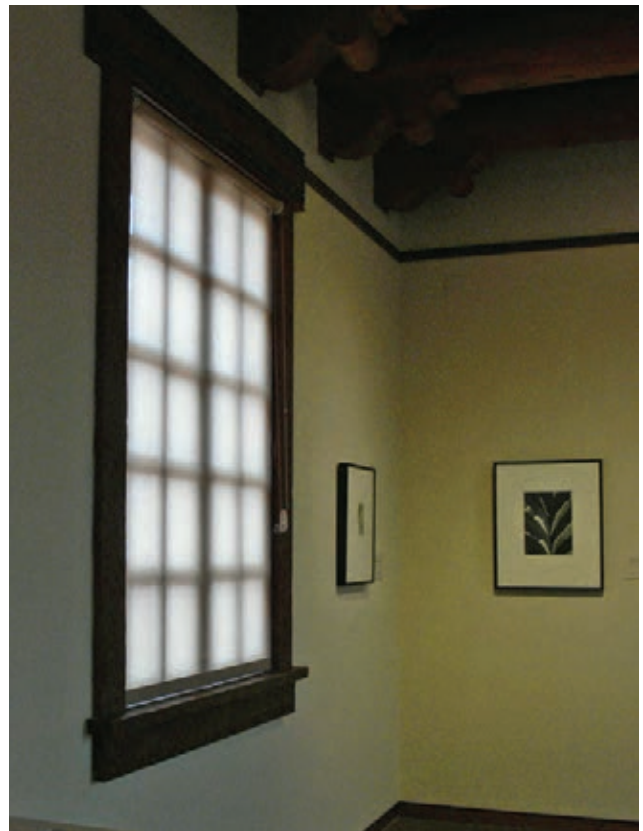
The windows' existing UV film, which had been added at some point in the past, had deteriorated to the point that edges were peeling and curling, and it no longer served its purpose. Sol Solutions, a Santa Fe-based window tinting company, replaced the existing UV film with new film to reduce the visible and UV light in the spaces, with minimum intrusion of the historic architectural features. The new UV film also increases the energy efficiency of the windows. A great deal of

A window with a new UV-filtering cover in the Beauregard Gallery.  
Photograph by Michelle Gallagher Roberts.

We also replaced the non-moveable window covers with roller screen shades. These shades offer additional unobtrusive UV protection for the artwork, historic woodwork, and furniture. The sheer material allows light to enter the room while reducing glare and softening the view to the outside. We have the option of raising the window shades and allowing visitors to view the building architecture and surrounding cityscape when light control isn't mandatory for an exhibition, or during different times of the year when the sun doesn't shine directly through a window.

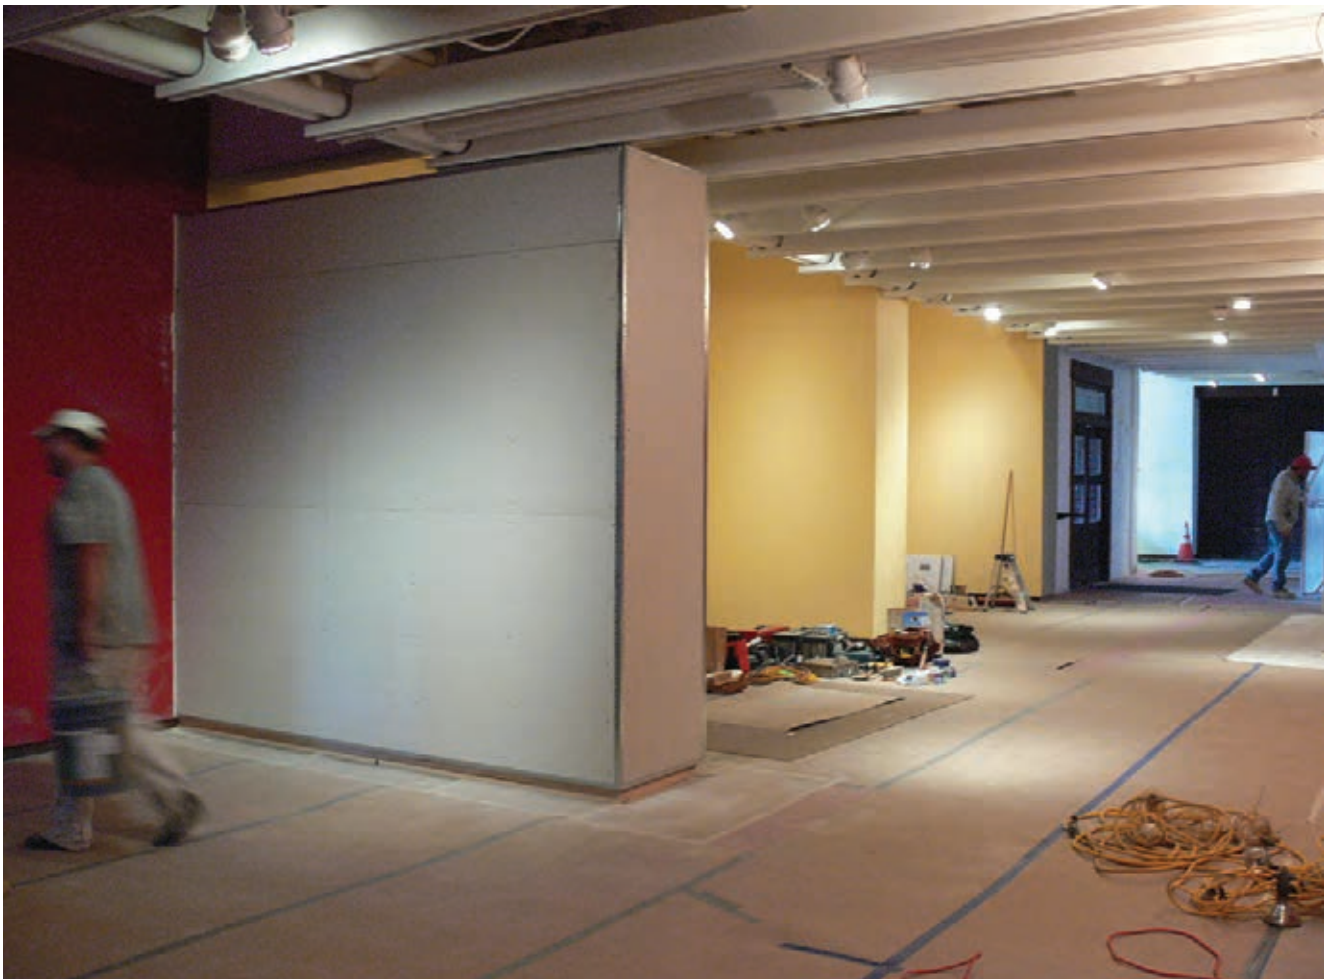
The Goodwin Gallery during the renovation process. The newly uncovered windows at the far end shed light on the entrance to St. Francis Auditorium. Photograph by Michelle Gallagher Roberts.

The lower floors of the building have skylights in almost all the bays. They historically allowed natural light into the spaces, as windows are limited in this area. Over the past 100 years, various directors have made the decision to cover or reopen the openings. New Mexico's light is very intense, and difficult to deal with in an exhibition space. The skylights also leaked repeatedly. Taking advantage of current technology, staff worked with J.M. Evans, Inc., to reintroduce this feature back into the galleries in a limited fashion. Workers rebuilt three skylight bays with new insulation, and increased the pitch and slope so they would drain better and reduce the chance of leaking. Unfortunately, given the manufacturing lead time and the

limited time frame of the renovation, they were not ready for the November reopening. Three Kalwall S-Line skylights were added in March 2018. The new skylights allow a diffused and muted light into the spaces that changes throughout the day and with the weather.

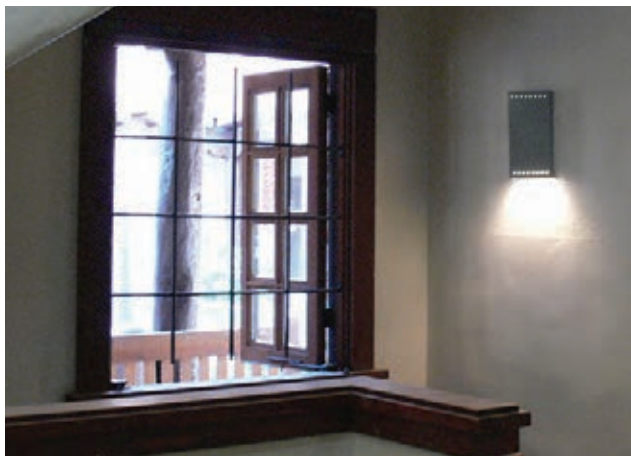
The new stairway wall sconces combine tinwork, a traditional genre, with a contemporary design. Photograph by Michelle Gallagher Roberts.

thoroughly modern design. They replace frosted glass and chrome stairway sconces from the 1980s.

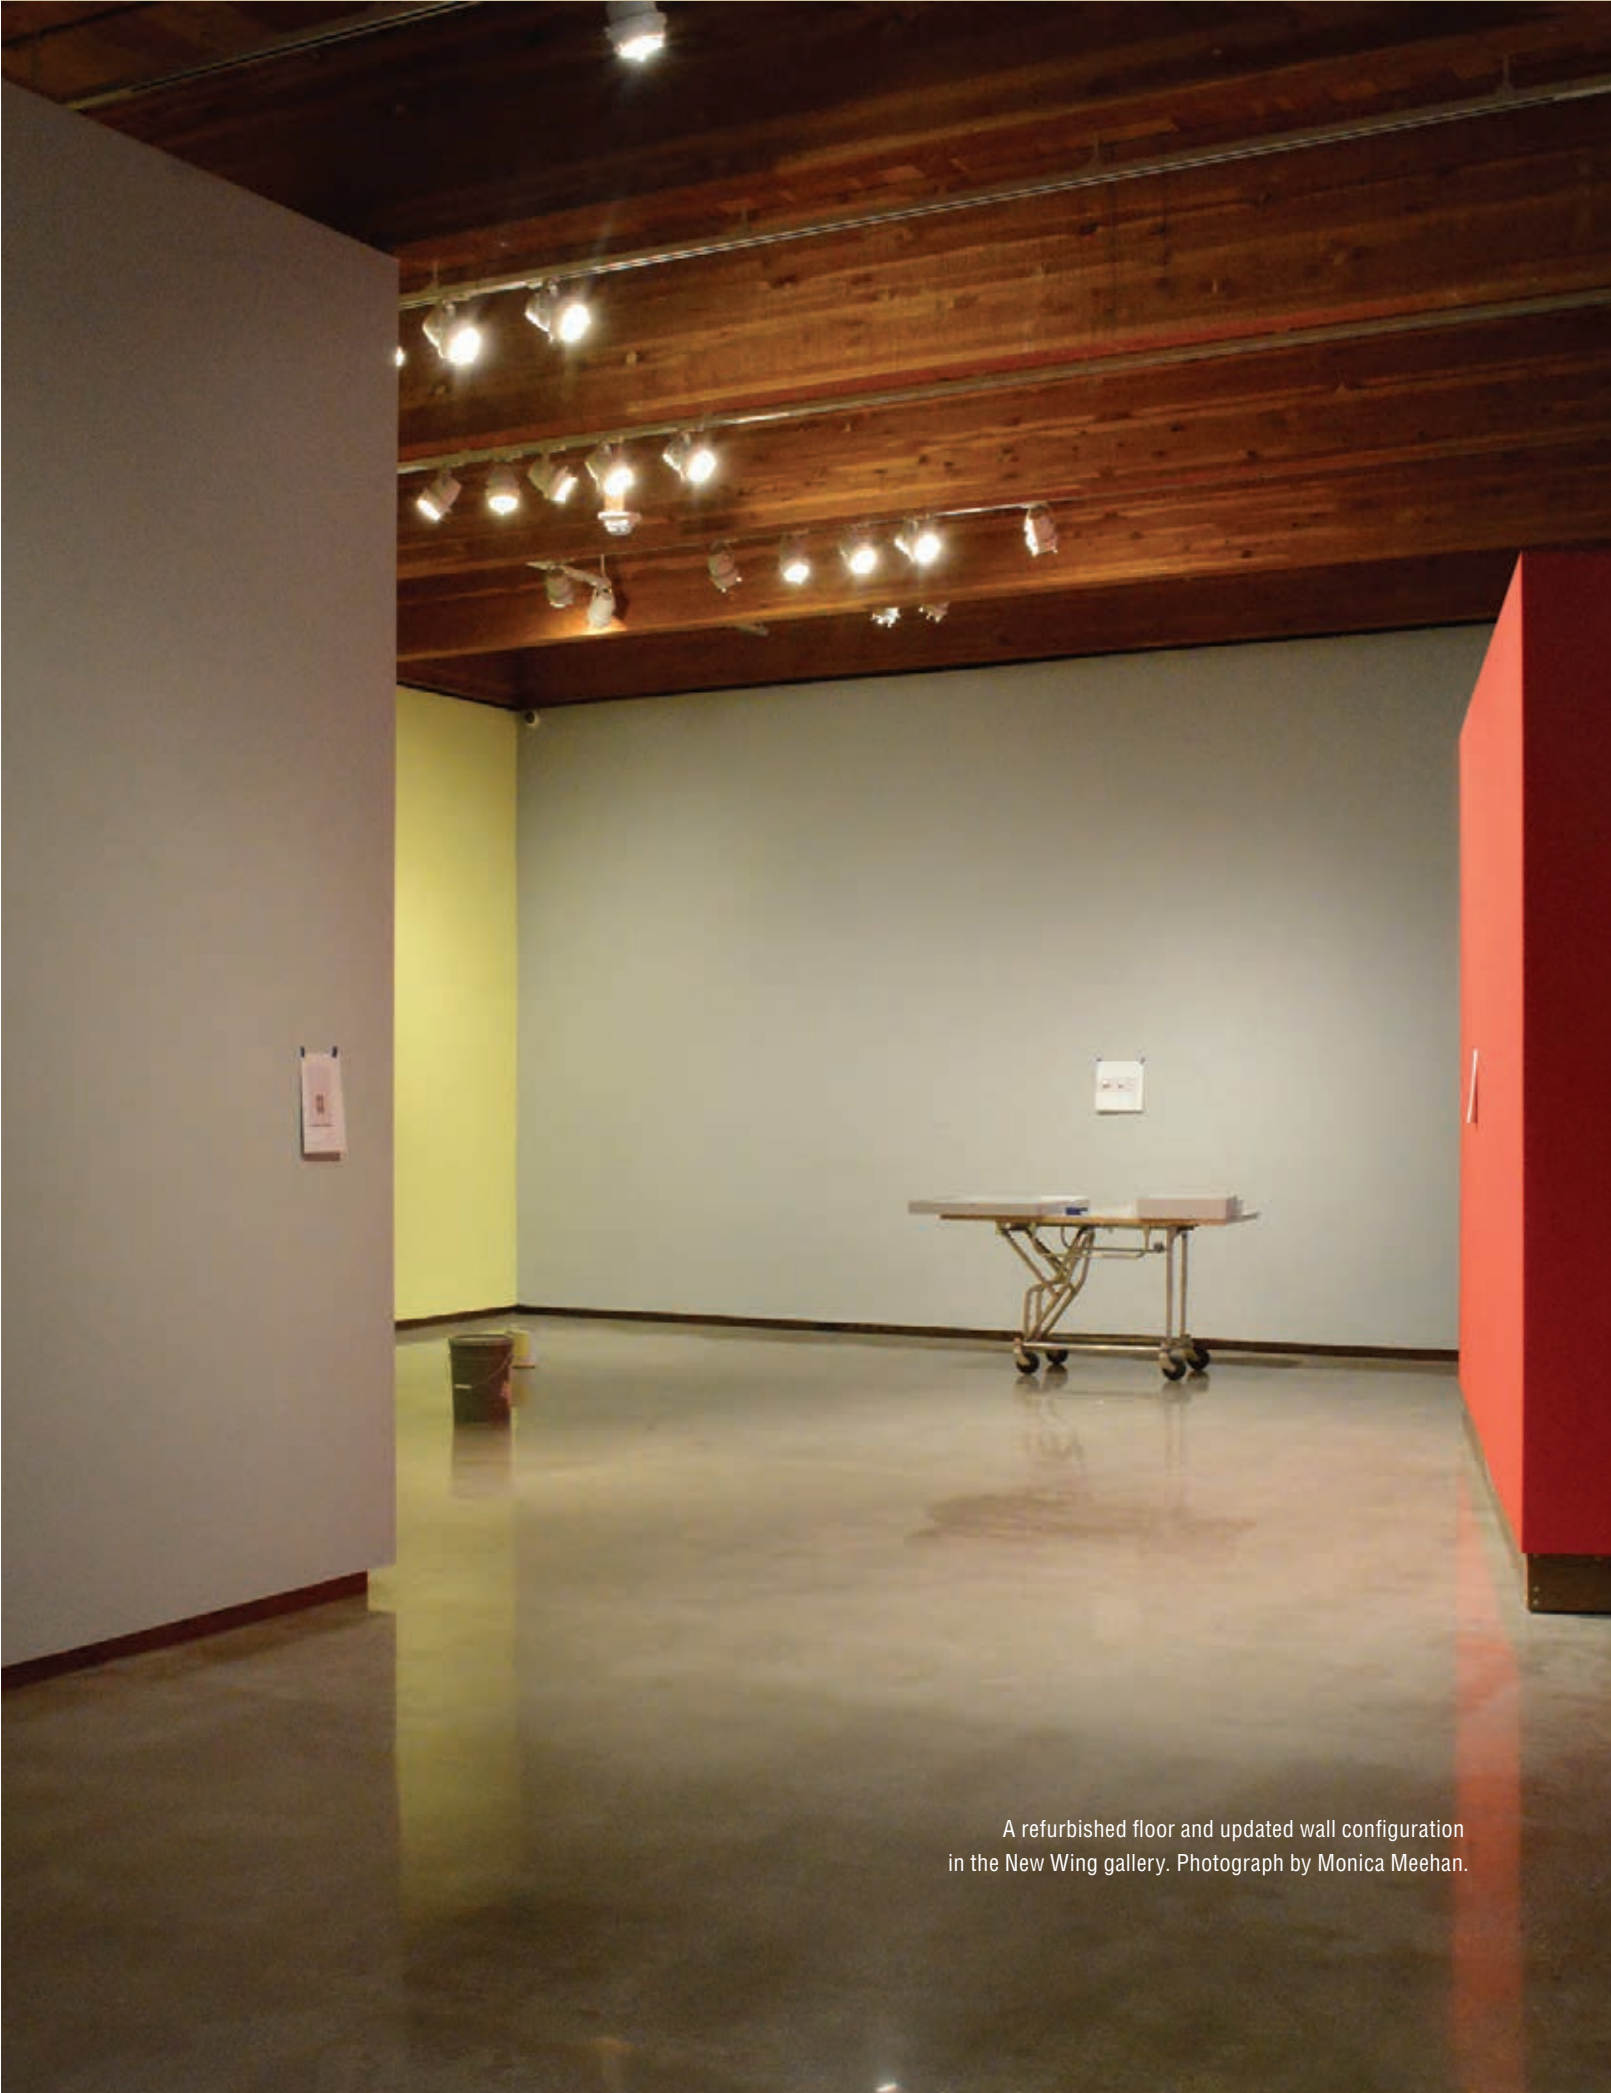
A refurbished floor and updated wall configuration in the New Wing gallery. Photograph by Monica Meehan.
