## A NEW LEASE ON Light

Take a peek behind the (busy) scenes of the Museum of Art's epic centennial renovation.

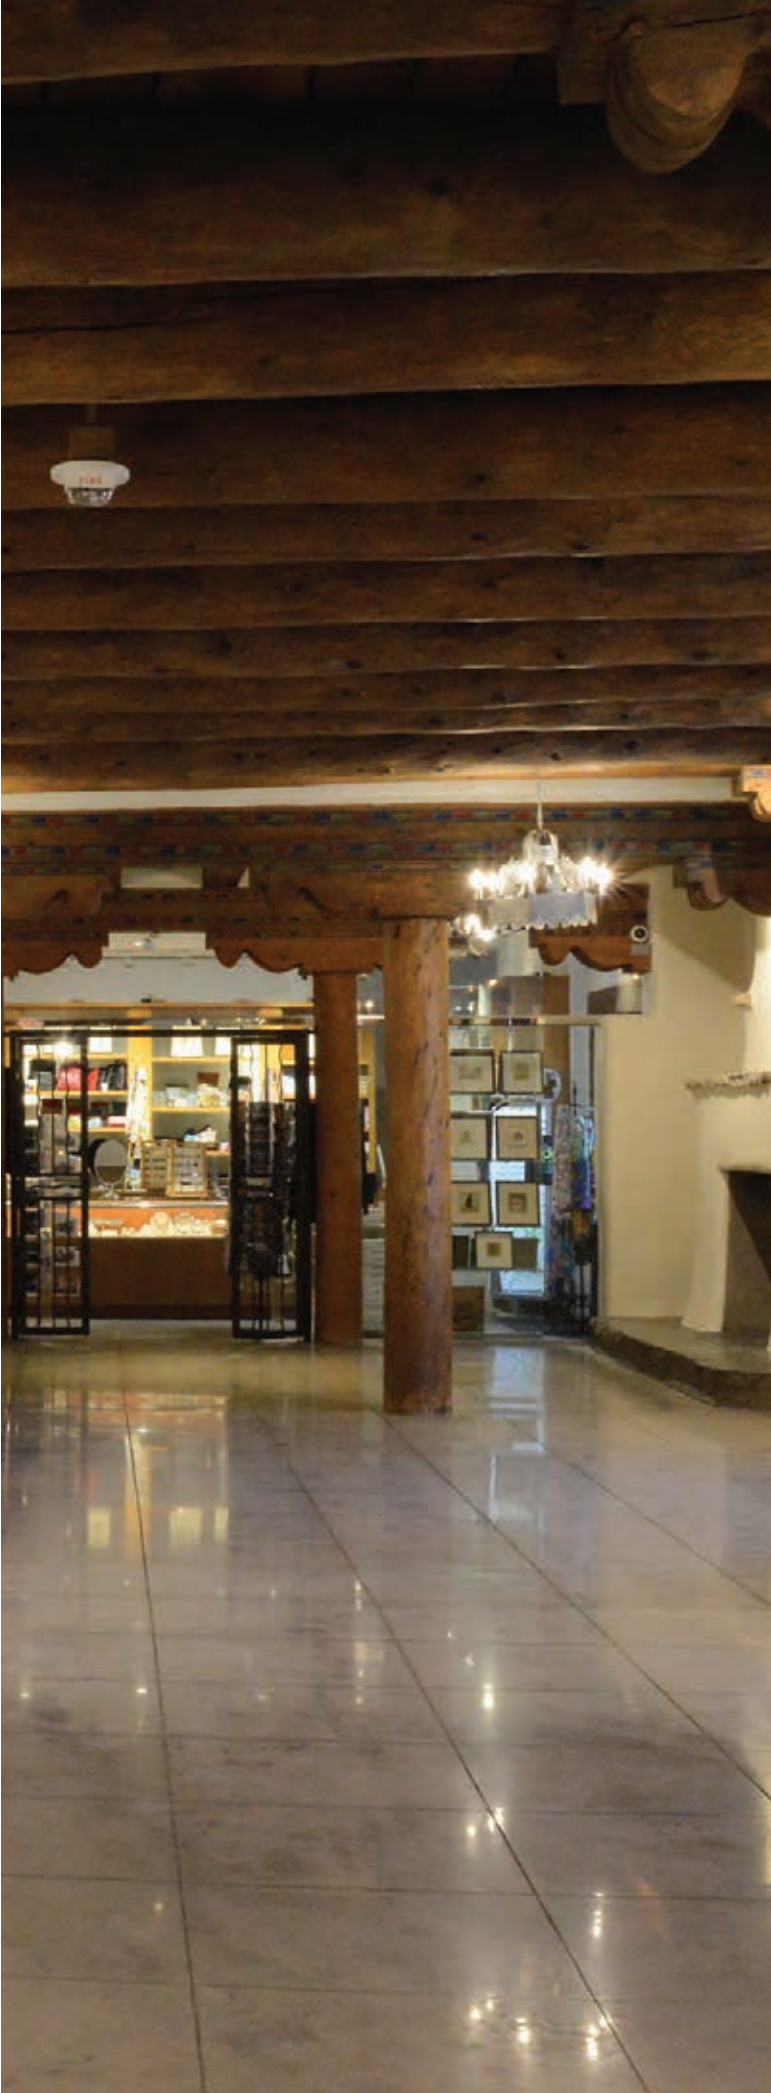
Workers from Advanced Concrete Design in the Beauregard Gallery, after they removed the initial layer from the floors with a terrazzo grinder. Photograph by Michelle Gallagher Roberts.

The most complex and least predictable part of the planned renovations was the restoration of the floors throughout the building. When the museum first opened its doors in 1917, the hand-poured concrete floors were a light color which helped to reflect light up onto the walls and ceiling. A detailed examination of the concrete throughout the museum showed a mix of challenges. After 100 years of use and various treatments, the floors had become dark, discolored, and uneven. While the floors had some remedial treatment in the 1980s, by 2017, the floors were again in acute need of attention. In various areas, the surface of the concrete was spalling (partially deteriorating and separating).

Advanced Concrete Design, the floor subcontractor, completed the first stage with a terrazzo grinder, which uses different grades of stones (from coarse to polishing) to achieve a glossy finish. ACD workers also hand-cleaned about 15,000 linear feet of joints. The grinding and polishing process removed approximately  $\frac{1}{32}$  inch of floor surface, and in some areas, exposed the sand and stone aggregate below. ACD applied a water-based densifier to the surface in order to solidify and strengthen it. They consolidated voids and areas of spalling with a color-matched concrete epoxy, and applied a final two coats of a clear low-sheen sealer throughout the museum.
